**DEPARTMENT OF TRANSPORTATION**

Contract #: 04-0120F4Cty: SF/ALA Rte: 80 PM: 13.2/13.9File #: 1.28**WELDING INSPECTION REPORT****Resident Engineer:** Casey, William**Address:** 333 Burma Road**City:** Oakland, CA 94607**Report No:** WIR-028094**Date Inspected:** 03-Aug-2012**Project Name:** SAS Superstructure**OSM Arrival Time:** 700**Prime Contractor:** American Bridge/Fluor Enterprises, a JV**OSM Departure Time:** 1930**Contractor:** American Bridge/Fluor Enterprises, a JV**Location:** Job Site**CWI Name:** As noted below**CWI Present:** Yes No**Inspected CWI report:** Yes No N/A**Rod Oven in Use:** Yes No N/A**Electrode to specification:** Yes No N/A**Weld Procedures Followed:** Yes No N/A**Qualified Welders:** Yes No N/A**Verified Joint Fit-up:** Yes No N/A**Approved Drawings:** Yes No N/A**Approved WPS:** Yes No N/A**Delayed / Cancelled:** Yes No N/A**Bridge No:** 34-0006**Component:** SAS OBG**Summary of Items Observed:**

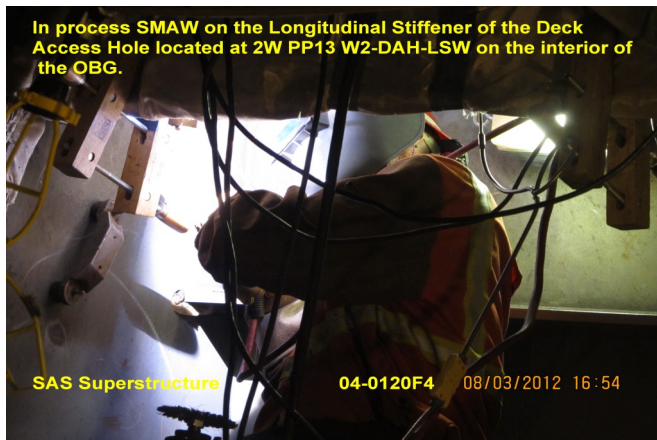
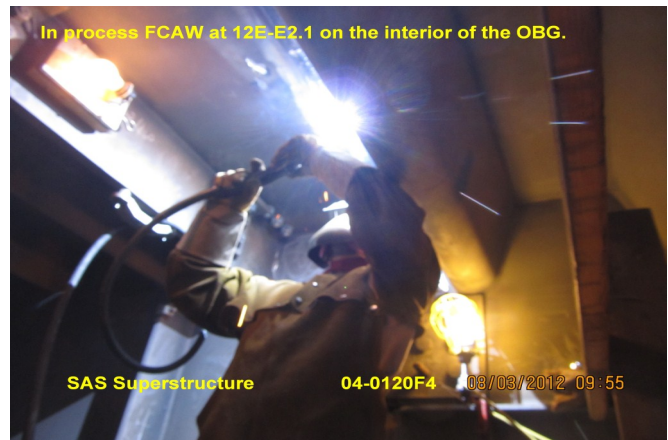
This QA Inspector randomly observed ABF/JV qualified welder Xiao Jian Wan #9677 continuing to perform production welding using the Flux Core Arc Welding (FCAW) process in the 4G overhead position on the A deck joint at 12E-E2.1 on the interior of the OBG. The splice joint was preheated to greater than 200 degrees Fahrenheit using Miller Proheat 35 Induction Heating System with the heater blanket located at the opposite side of the deck prior/during welding. This QA Inspector observed QC Inspector Salvador Merino verify prior to the start of welding operations, that the minimum preheat temperature as per the approved WPS was established; and afterwards verified that the welding parameters (Amps, Volts and Travel Speed) were in accordance with ABF-WPS-D1.5-1-3110-4. This QA Inspector made subsequent observations throughout the shift to monitor quality and noted the work at this location is in progress and appeared to be in general conformance with the contract specifications.

Deck Access Hole (DAH) at 2W PP13 W2-LSW on the interior of the OBG. The splice joint was preheated to greater than 200 degrees Fahrenheit using Miller Proheat 35 Induction Heating System with the heater blanket located at the opposite side of the deck prior/during welding. QC Inspector Steve Jensen was observed measuring the preheat temperature and setting the parameters to ensure compliance with the welding procedure specification (WPS) ABF-WPS-D1.5-1012-3. The welder was observed using a small disc grinder to blend the start/stop edges of the work to provide a smooth transition. The welder was observed utilizing 3.8mm E9018-H4R electrodes drawing amperage of 136. The electrodes were obtained from a baking oven verified by this QA Inspector. On a subsequent observation this QA Inspector monitored the work for quality and noted that it was in progress and appeared to be in general conformance with the contract documents.

This QA Inspector randomly observed ABF/JV qualified welder Jim Quan Huang #9340 continuing to perform 3G vertical position production welding using the Shielded Metal Arc Welding (SMAW) process at 12E/13E-B1 on the interior of the OBG. This QA Inspector observed ABF personnel using propylene gas torch to preheat the joint being welded prior welding. This QA Inspector observed QC Inspector Salvador Merino use a infra- red temperature gauge to verify the preheat temperature of more than 150°F. This QA Inspector performed a verification of the welding parameters and observed 132 amperes of the 3.2mm E7018-H4R electrodes. The welding appeared to comply with Welding Procedure Specification (WPS) ABF-WPS-D1.5-1040A-Revision 1. This QA Inspector made subsequent observations throughout the shift to monitor quality and noted the work at this location was completed on this date and appeared to be in general conformance with the contract specifications.
